Coal Combustion Waste Impoundment

Round 5 - Dam Assessment Report

Winyah Generating Station (Site #004)

Santee Cooper

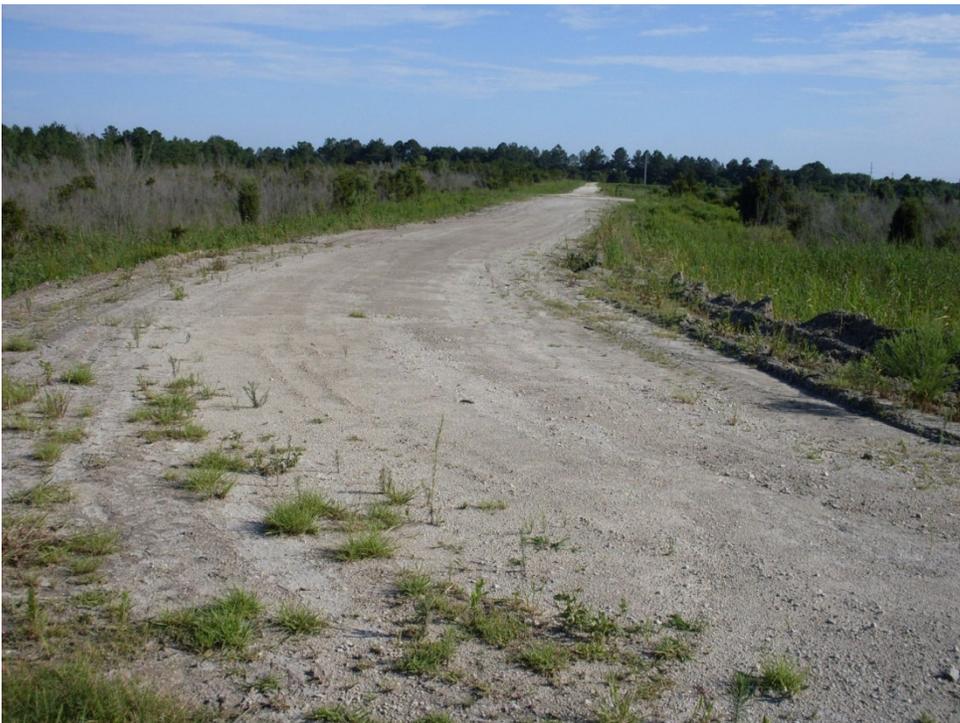
Photo B2-7: Crest of Cross Dike in Unit 2 Slurry Pond– Viewed South (Original Middle “Finger Dike” Had Been Recently Extended Northerly To The North Perimeter Dike To Divide The Pond Into Two Cells).

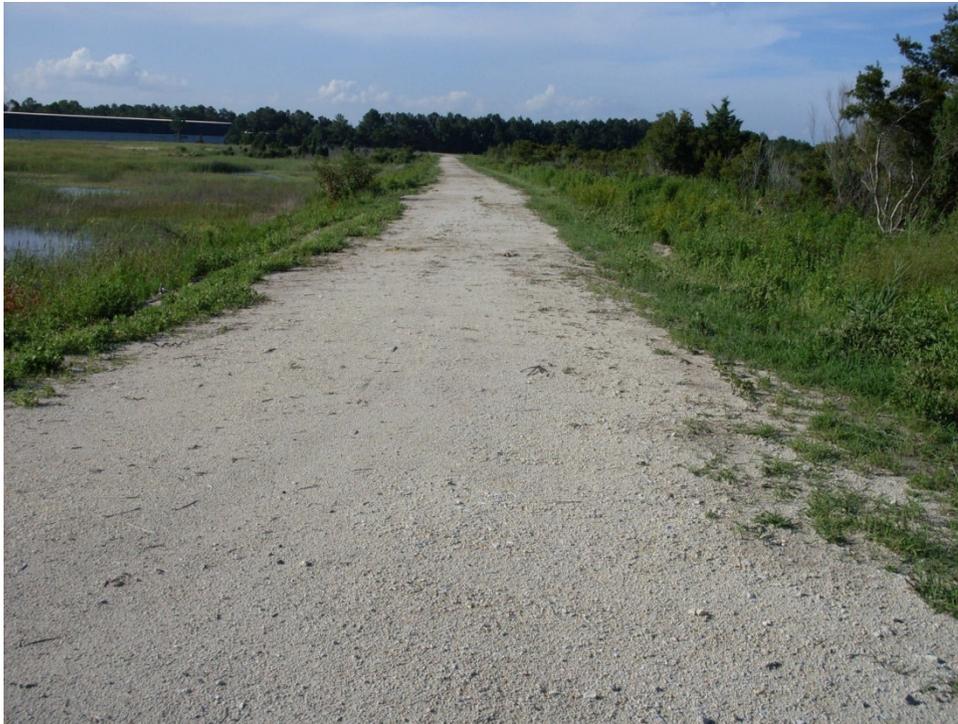
Photo B2-8: Crest of Cross Dike in Unit 2 Slurry Pond– Viewed North.

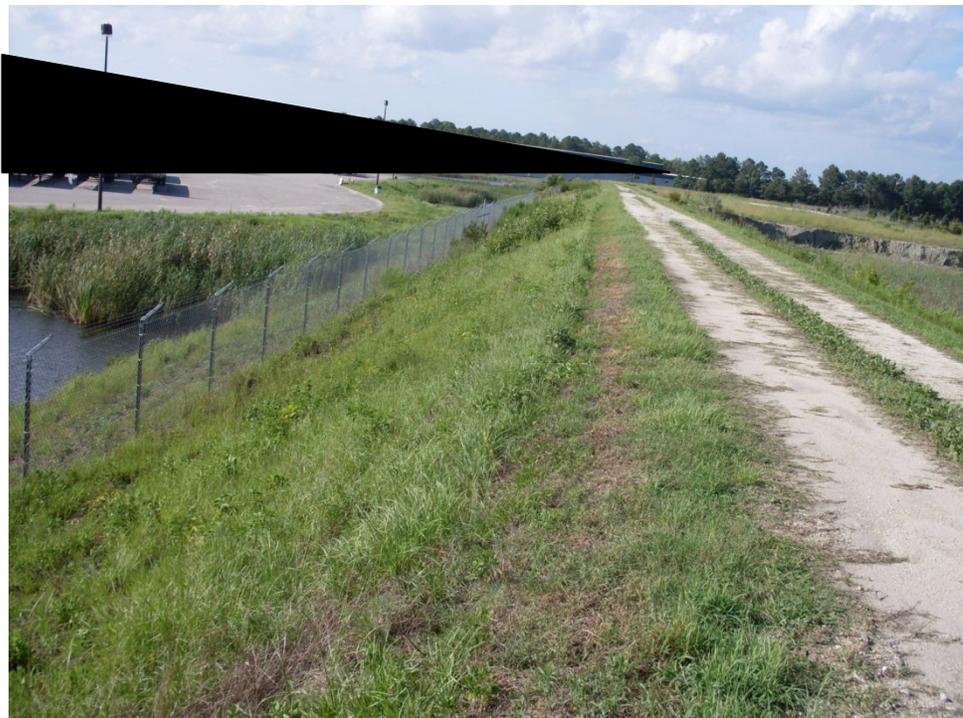
Photo B2-9: Crest and Outside Slope of Perimeter Dike West Side of Unit 2 Slurry Pond– Viewed North.

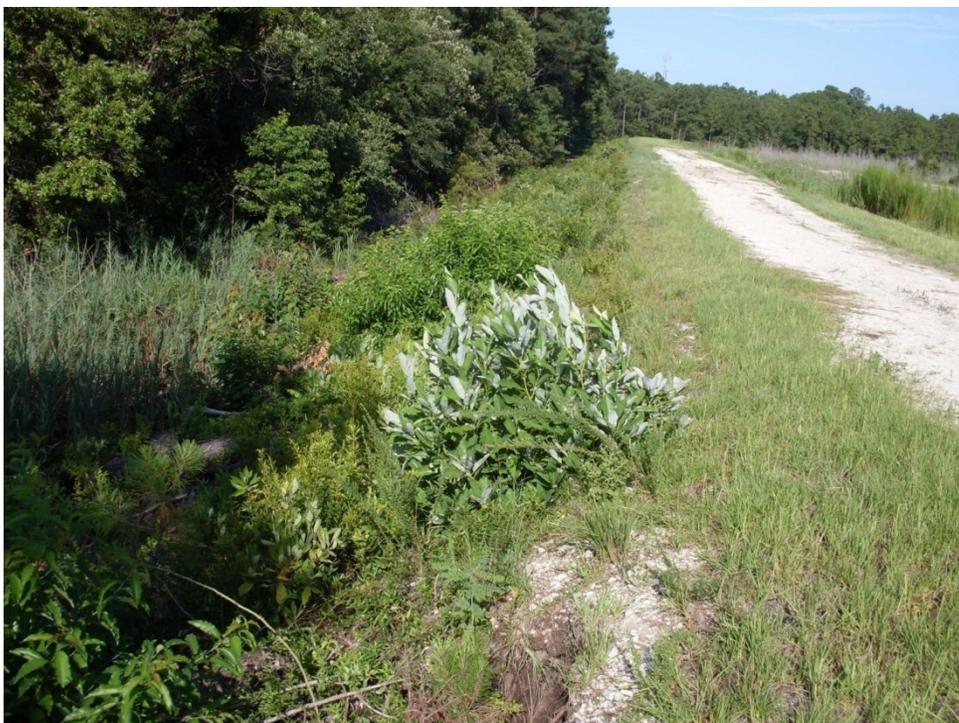
Photo B2-10: Outside Slope of Perimeter Dike North Side of Unit 2 Slurry Pond West of Cross Dike – Viewed East.

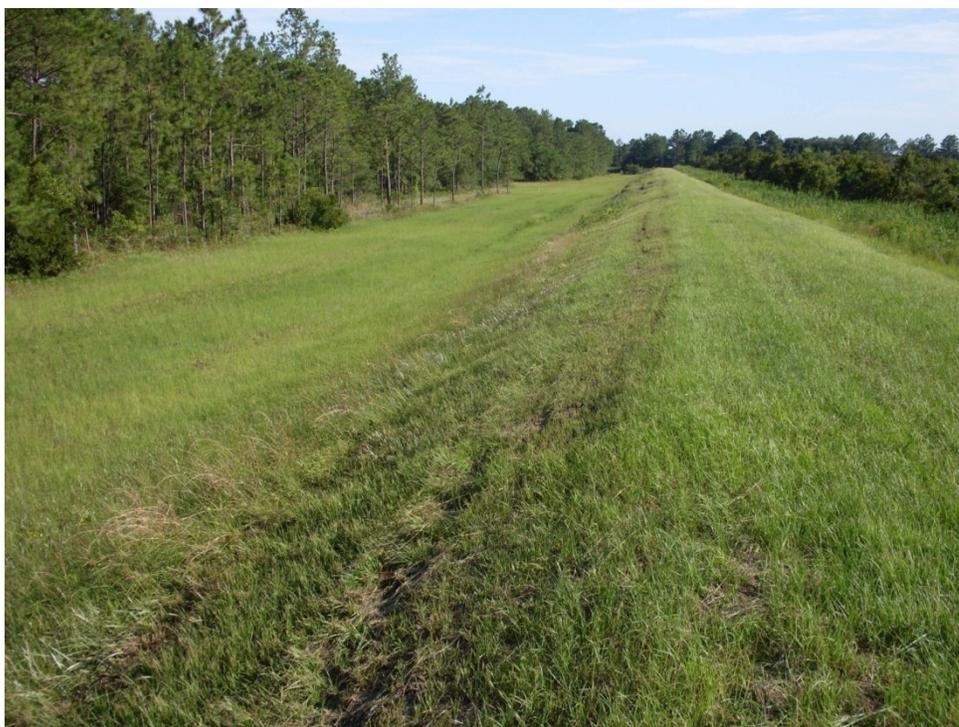
Photo B2-11: Outside Slope of Perimeter Dike East Side of Unit 2 Slurry Pond– Viewed South.

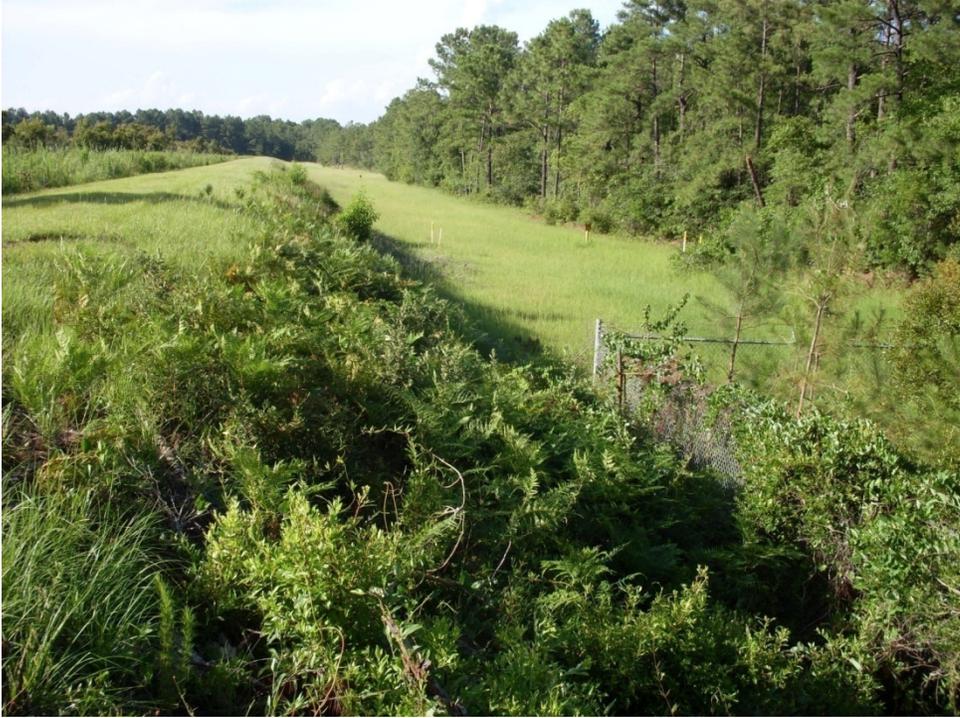
Photo B2-12: Outside Slope of Perimeter Dike East Side near Southeast Corner of Unit 2 Slurry Pond – Viewed South.

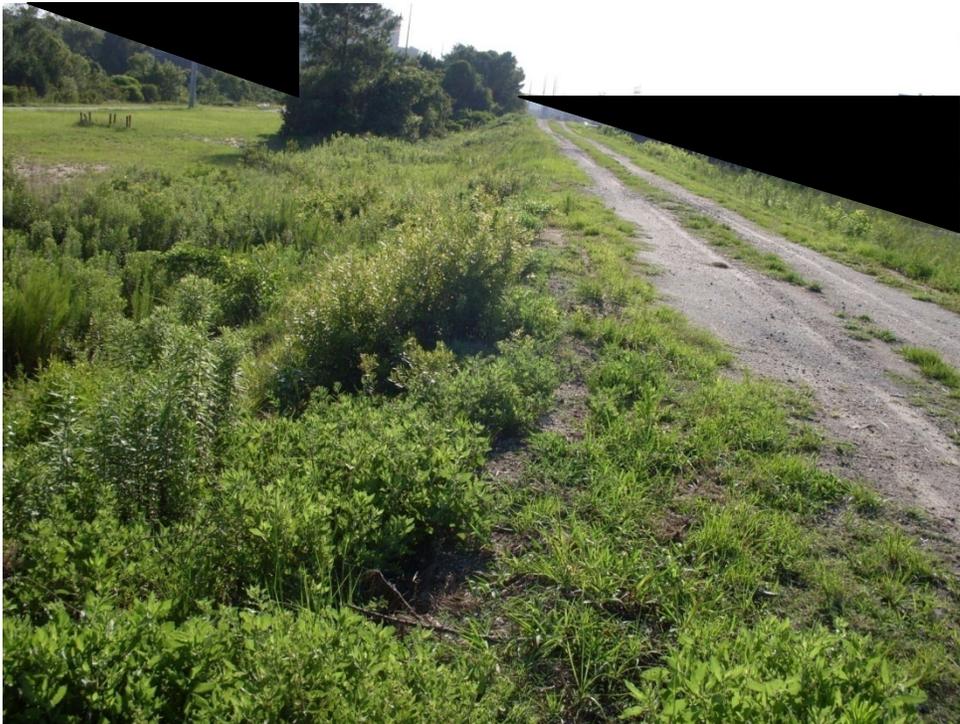
Photo B2-13: Outside Crest and Slope of Perimeter Dike South Side of Unit 2 Slurry Pond West of Cross

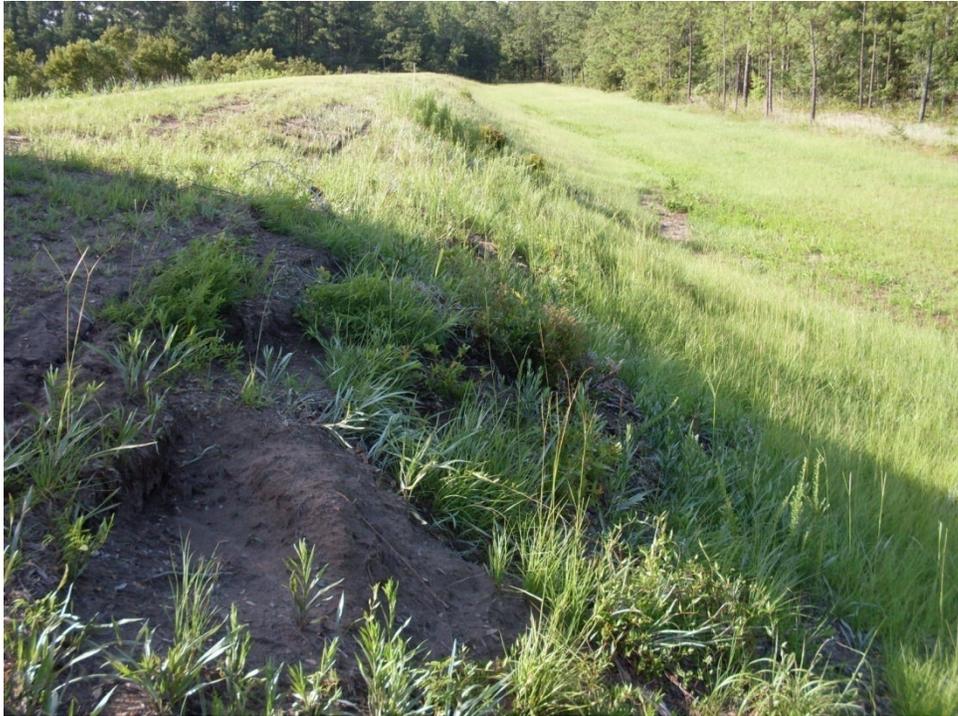
Photo B2-14: Outside Slope of Perimeter Dike East Side of Unit 2 Slurry Pond
– Viewed South

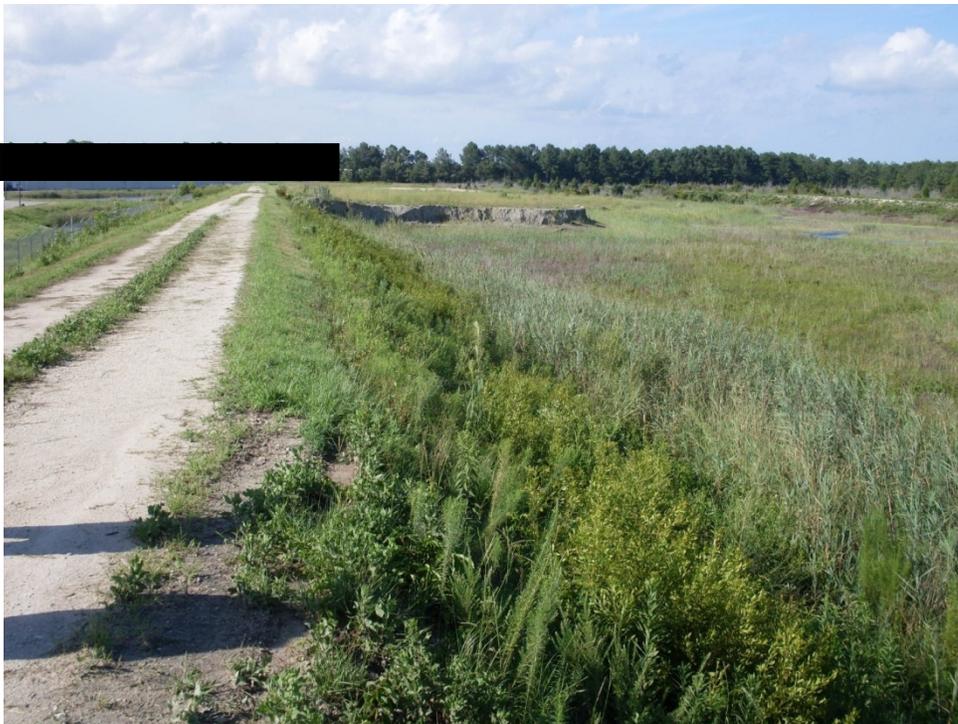
Photo B2-15: Inside Slope of Perimeter Dike West Side of Unit 2 Slurry Pond–
Viewed North.

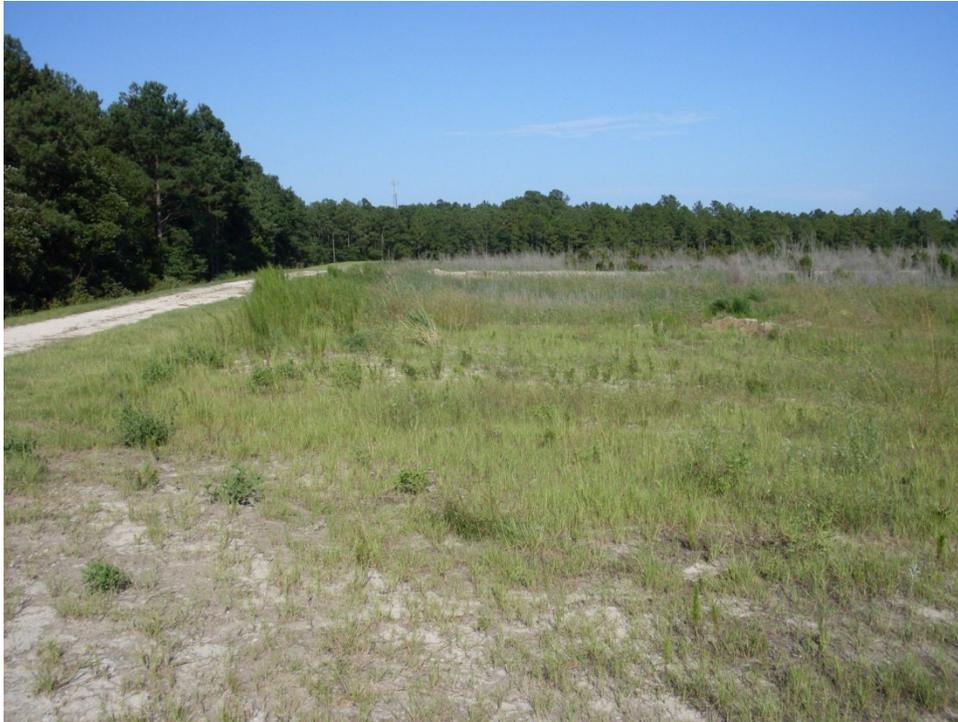
Photo B2-16: Inside Slope of Perimeter Dike North Side of Unit 2 Slurry Pond West of Cross Dike – Viewed East.

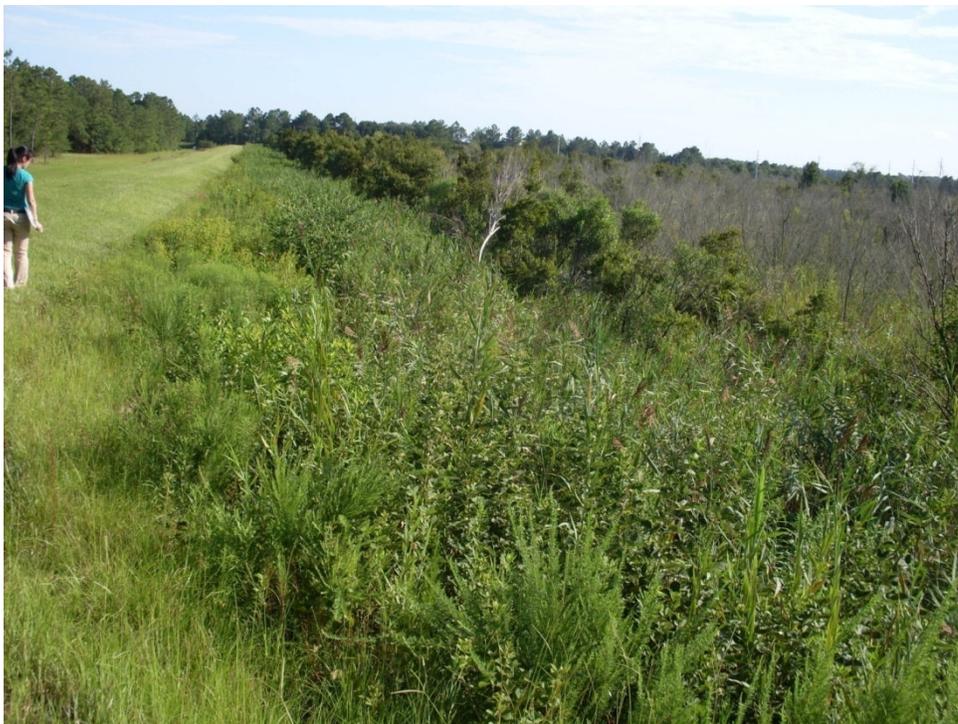
Photo B2-17: Inside Slope of Perimeter Dike East Side of Unit 2 Slurry Pond– Viewed South.

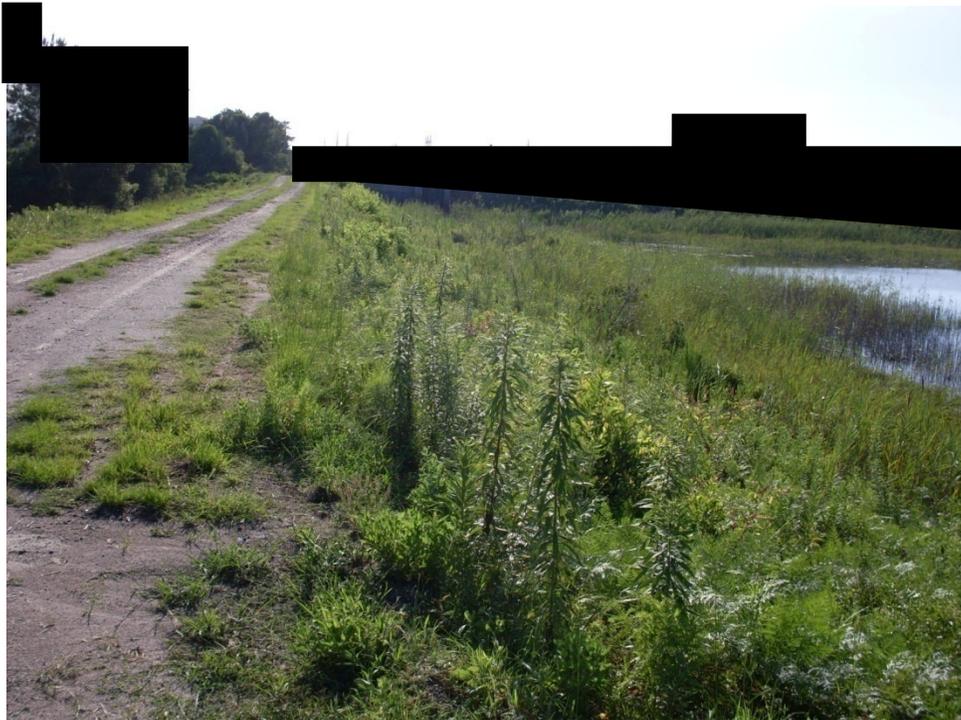
Photo B2-18: Inside Slope and Crest of Perimeter Dike South Side of Unit 2 Slurry Pond West of Cross Dike – Viewed West.

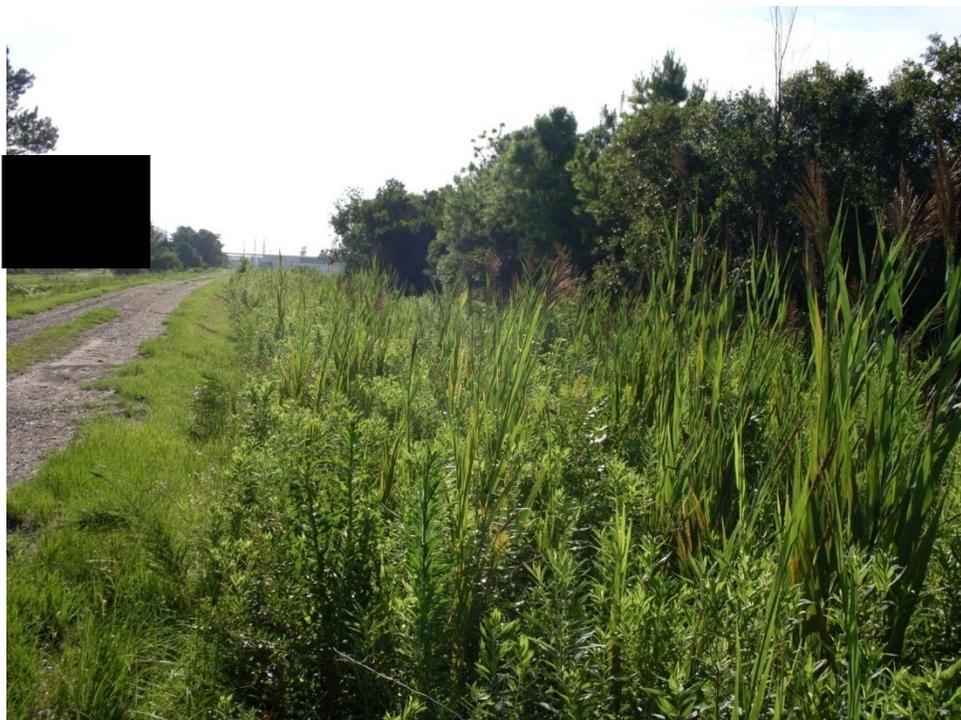
Photo B2-19: Inside Slope and Crest of Perimeter Dike South Side of Unit 2 Slurry Pond East of Cross Dike– Viewed West.

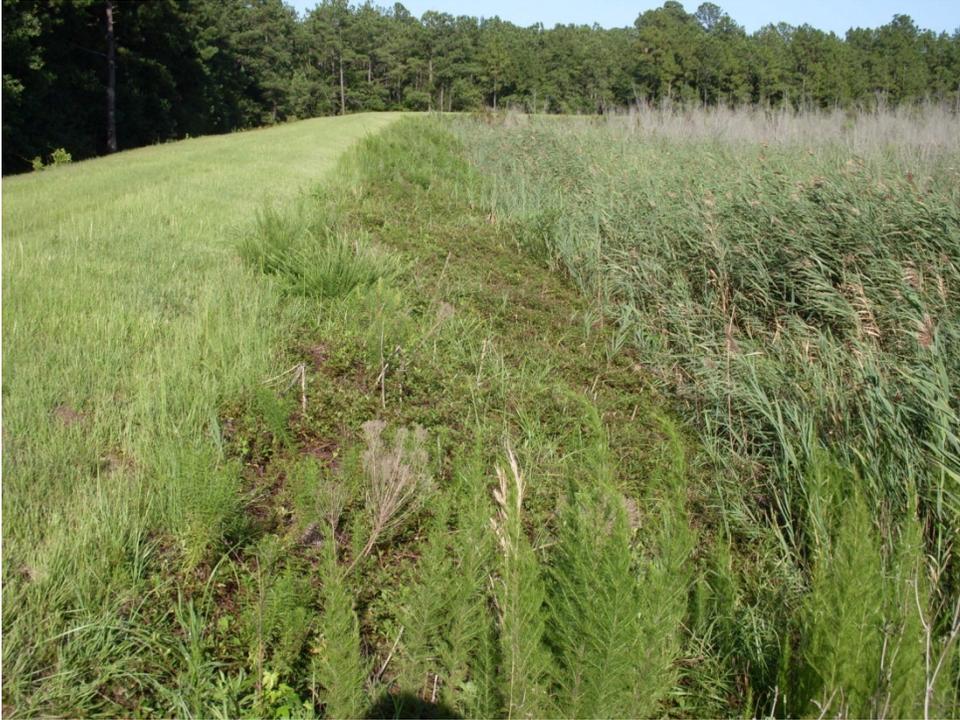
Photo B2-20: Inside Slope of Perimeter Dike North Side of Unit 2 Slurry Pond East of Cross Dike – Viewed East.

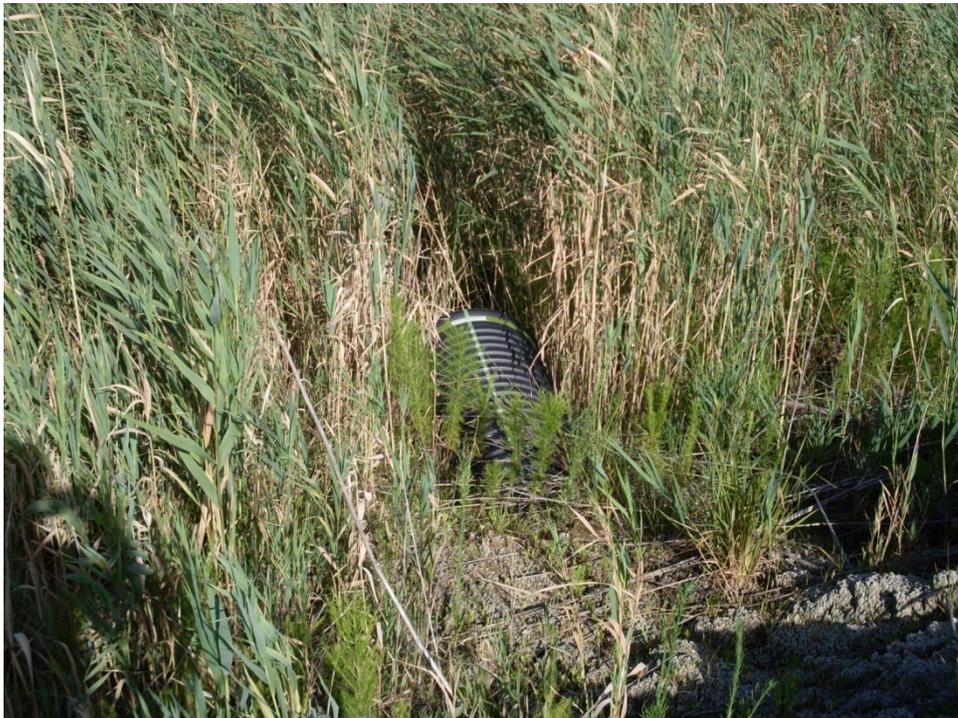
Photo B2-23: Inlet of Corrugated HDPE Pipe Under the North (Extended) Portion of the Cross Dike in Unit

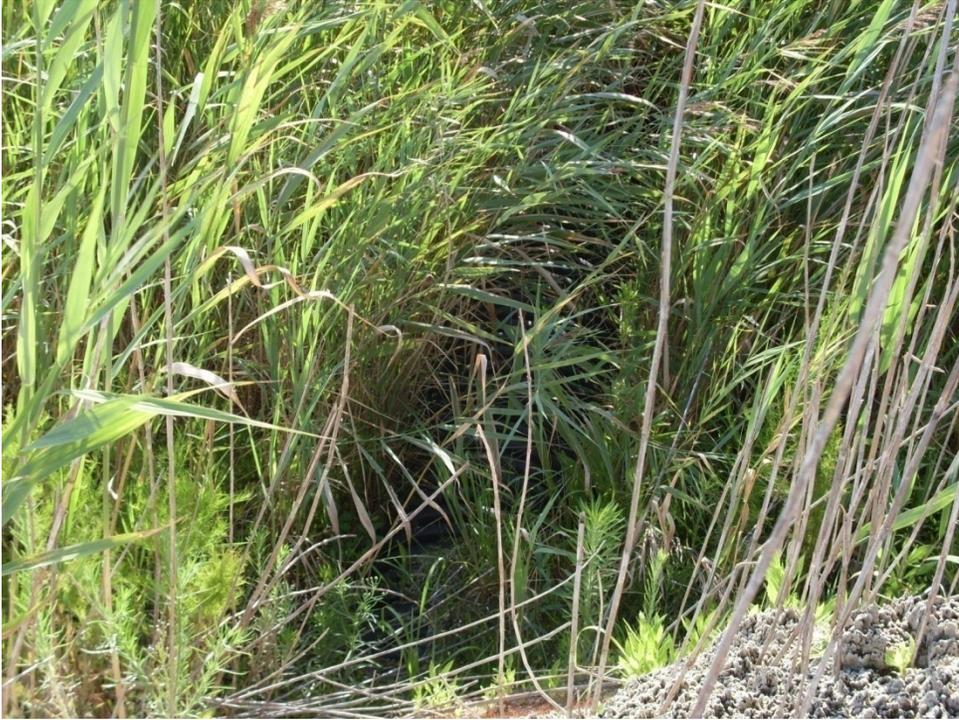
Photo B2-24: Outlet of Corrugated HDPE Pipe Under the North (Extended) Portion of the Cross Dike in Unit 2 Slurry Pond.

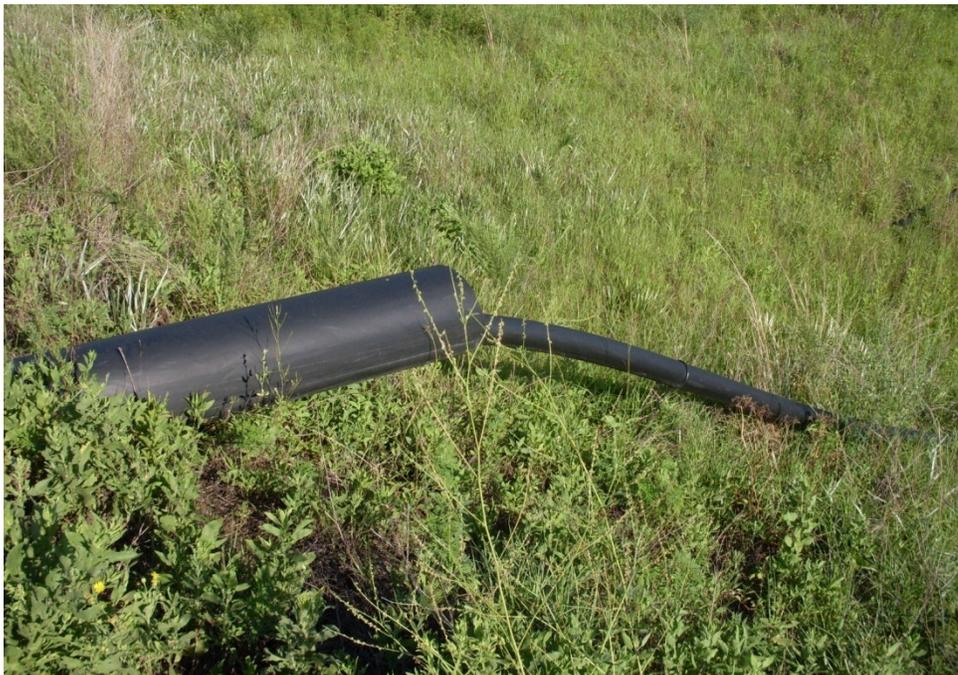
Photo B2-25: Plastic Pipe Conveying Stormwater Pumped Unit 2 Slurry Pond to Intake Channel Located at Outside Slope of South Perimeter Dike at Southwest Corner. (Note Large Diameter Casing Pipe within which Discharge Line – Smaller Pipe – Passes under Crest of Dike.)
